EVALUATION OF
CRACKED BRIDGE DECKS TREATED
WITH VARIOUS
HIGH MOLECULAR WEIGHT
METHACRYLATE RESINS
FOR THE
MONTANA DEPARTMENT OF TRANSPORTATION
WJE NO. 981825
July 27, 2000

EVALUATION OF
CRACKED BRIDGE DECKS TREATED
WITH VARIOUS
HIGH MOLECULAR WEIGHT
METHACRYLATE RESINS
FOR THE
MONTANA DEPARTMENT OF TRANSPORTATION
WJE NO. 981825

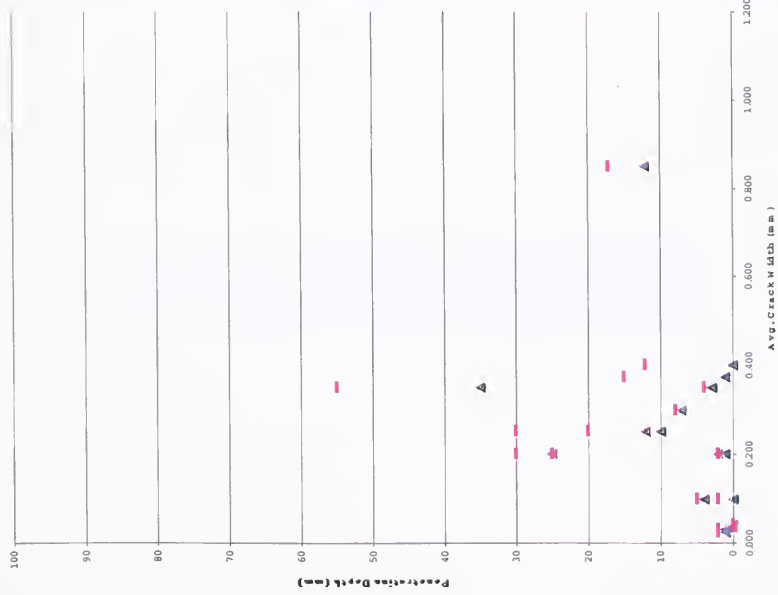
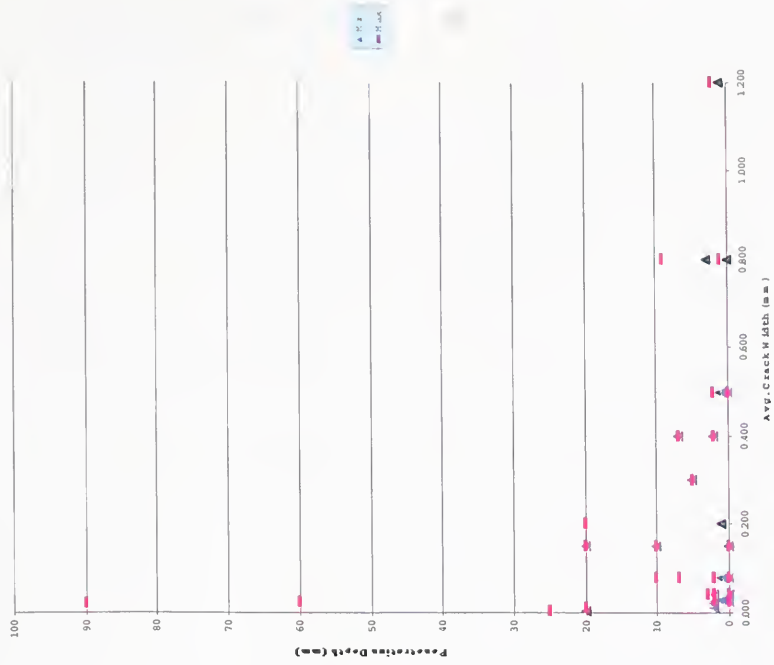
Figure 6 – Depth of penetration versus crack width for high and low elongation resins

determined to be high (30 percent) elongation resins. Transpo T70-10, Sika Pronto 19, and Transpo T70-X are assumed to be low (less than 10 percent) elongation resins. The elongation of the resins supplied by Harris Specialty Chemicals and American Concrete Systems is uncertain. Table 5 summarizes the range of resin penetration for the various resins. Figure 6 shows plots of the range of resin penetration for various crack widths. Both high and low elongation resin types had a large range of penetration depths. Figure 7 shows the range of resin penetration versus crack widths for all cores and resins. Generally, penetration was deeper in cracks with widths less than 0.4mm than for cracks with widths of 0.5mm to 1.2mm. No significant difference in the penetration of high versus low elongation resins was seen in this study.
